Issues of Compatibility Between Nanomaterials and Aluminum Scanning Electron Microscope Mounts

by Donovan Harris

ARL-MR-601 December 2004

Army Research Laboratory

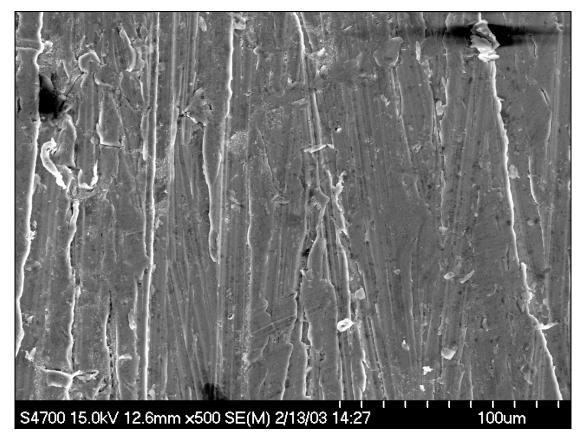
Most aluminum mounts for use in SEMs are machine lathed. That process produces the rough surface topography seen in figure 1. Evident are large areas into which nano-sized materials could be deposited and hence obscured. The surface charging of loose surface debris is typical, even after solvent cleaning in a sonic bath. The charging at the upper right of figure 1 was produced by an aluminum snag or spall. While not a surface for making measurements of

Figure 1. Typical lathe finished surface.

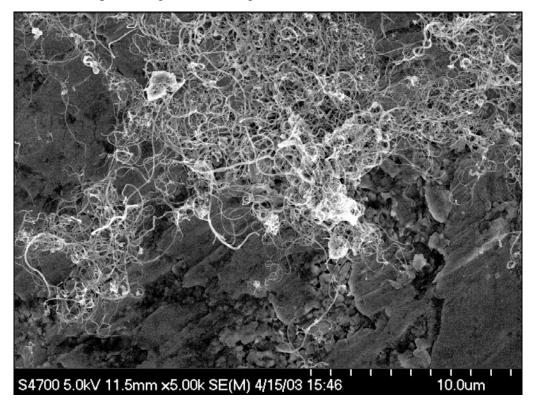
nanoscale materials, it was thought to be satisfactory for assessing tube dispersions (figure 2). Here, a small mat of partially dispersed tubes readily over lies most of the disparities of the aluminum mount surface topology. The image in figure 2 was manually modified using its histogram to adjust the black and gamma values. The differences in the white levels are mainly a function electron transport along the tubes to ground.

Figure 2. A mat of nanotubes on a lathe finished surface.

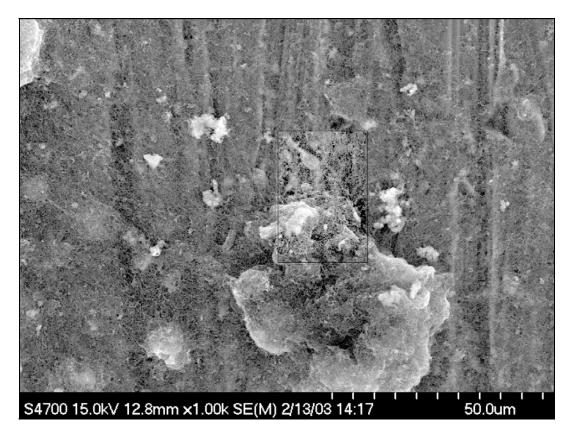
A partially dispersed gnarl with a mat of nanotubes can be seen in figure 3; another gnarl is found in the upper left. The tube mat has effectively diminished the edge effects evident in figure 1. However, the number and size of white/hot spots increased out of proportion with the change in magnification. Were these spots small tube gnarls, oxidized aluminum charging, or residual manufacturing impurities? The tubes had been purchased as meeting a specific level of purity, for targeted application purposes. Typically, the impurities are entrapped by the tube gnarl, but tubes in the gnarl can be entrained in the impurity. What should have been a quick look evolved into a more detailed analysis. The majority of the white spots were a result of charging on the aluminum spalls, which can act as crude capacitors. The nanotube mat has better transport properties, so a charge builds at a surface defect. The upper left gnarl experienced some charging, along with geometry-based electron scattering, to cause the observed white level. Similar effects are seen to a lesser extent on the large partially dispersed gnarl at lower center. These determinations required an additional four hours on the FE-SEM. The offline processing and analysis time changed from the projected 90 min to a full day.

Figure 3. Nanotube gnarls and mat on lathed surface.

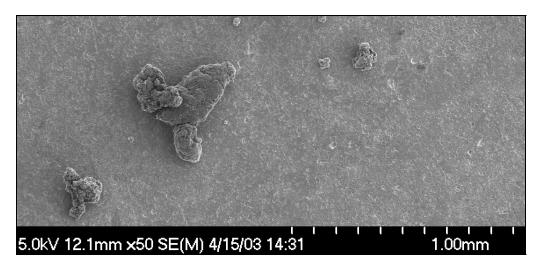
The alternative mount was an aluminum cylinder with a smooth but not polished surface, referred to as a slug by some suppliers. A micrograph with a magnification of 50× shows a range of tube gnarls (figure 4). The surface has neither large disparity nor obscuring edge effects. The inefficacy of the dispersion process is readily evident. Only the gamma value of the micrograph has been adjusted.

Figure 4. Cylinder/slug mount with tube gnarls.

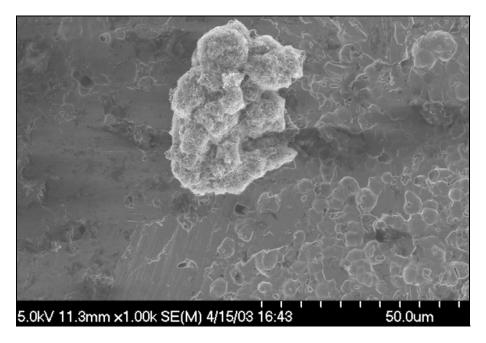
Increasing the magnification to $1,000 \times (1k \times)$ produced the surface charging seen in figure 5, as evidenced by large dark streak areas originating at the lower right of the tube gnarl. Several smaller dark areas, seen on the surrounding surface, exhibit no such behavior. If the solvent

Figure 5. Charging at gnarl with higher magnification.

sonication cleaning process was not effective, that would explain the wet looking dark spots. Contrast that with a lathed finished mount at $1k\times$ and $2k\times$ (figure 6) where no charging is seen.

If the rate of electrons impacting on the surface is approximately equal to the rate of electron drain at the ground point, then figure 5 type surface charging will not occur. The observed surface charging is not solely the result of surface conductivity. At constant emission current, the other factors are the beam voltage and the ground path. As stated earlier, except for EDS, all

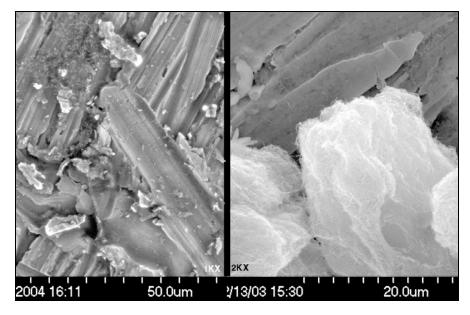
Figure 6. Two lathed surfaces with nanotubes at 20 kV and higher magnifications.

the specimens were examined at the same beam current, $2 \mu A$. While figures 4 and 5 were at 5 kV, figure 6 is at 20 kV.

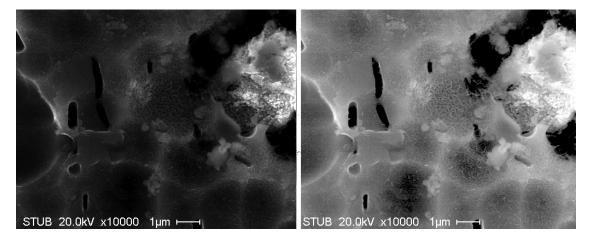
Figure 9. Mount at 10k× magnification, a beam voltage of 20 kV, and emission current of 12 μA .

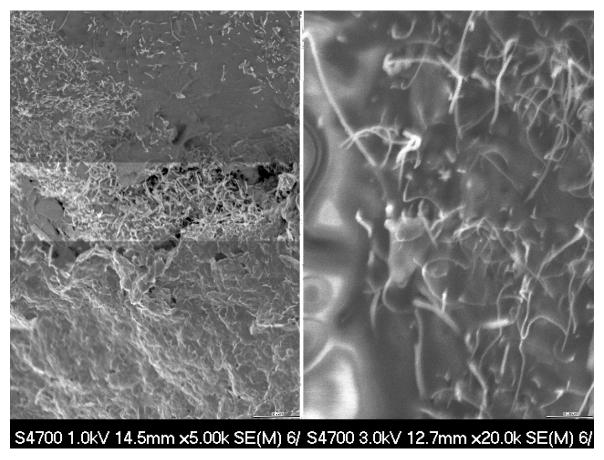
Using higher beam values only worked in a limited number of instances. When the nanotubes were dispersed in resin, a superior conductor was encased in an insulator, which was mounted on a good conductor. A uniform dispersion of tubes will mitigate those charging effects, especially if coupled with increased surface conductivity of the mount. In figure 10, a composite of two micrographs illustrate localized charging of carbon nanotube filled resins. The center portion of the left-hand panel was gamma corrected for better visual clarity. The lower area is mostly the surface of the filled material and the upper area is a fracture plane. The existence of a plane coupled with the nanotubes minimizes charging in that region. With an increase of beam voltage and magnification, charging of the resin and "arcing" between tubes occurred, as shown in the right panel. The resin charging is obvious. The "arcing" is limited to the center left of the panel, and to the right light grey triangular patch and involves five nanotubes. Those nanotube paths were not capable of transporting the excess electrons.

Figure 10. Nanotube filled resin at two magnifications and acceleration voltages. Emission current was 2 µA.

There were two reasons for using a flat mount and not a vise or clamping type mount with the filled resins specimens. First, the topography of the films was too rough for good contact except at isolated points. The second reason was electrical. Using a vise or clamping mount would physically produce a conductor-insulator-conductor-insulator-conductor setup. The charge conduction paths for the specimen in figure 10 were mainly through the resin matrix via the

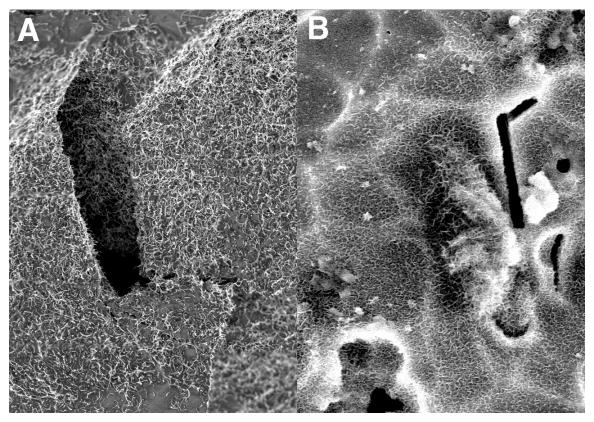
Polished SEM mounts, while providing a uniformly smooth surface, come with a different set a problems. Figure 11 is a compound micrograph of an aluminum mount and a nanotube filled resin. The identity of each only becomes evident in time.

Figure 11. An aluminum mount and a sample of tube filled resin. Which is the mount?

Is the surface labeled B in figure 11 sufficiently conductive to avoid charging and collect a good micrograph of nanotube dispersions? How much material will be lost into the voids in the surface of side B? Barring a thorough inspection before use in a SEM, these are hidden faults. The B surface was being used as the control surface for the examination of three dispersions. The stage rotation control arrows correctly indicate the direction of the image rotation, but the stage rotates opposite. With a single mount, that isn't an issue. Using a multimount, it is often a forgotten issue until the wrong sample appears on the screen. In the course of trying to find nonexistent nanotubes, the features shown were found. The scale of those features is consistent with results reported for nanotubes pretreated in the same manner as what should have been the first dispersion sample. The rotation issue clarified itself when the fourth stub was rotated into position and tube gnarls were seen. To achieve a better understanding of the surface in B, it was decided to perform an EDS elemental analysis of three separate areas.

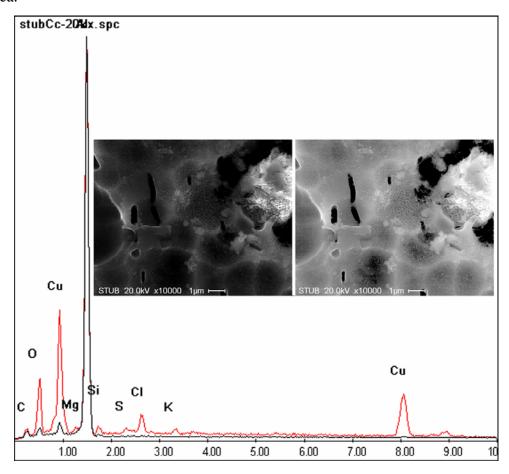
A real problem was revealed when the EDS analysis was performed on the mount. The outer mount areas possessed a uniform alloy composition, while areas of differing chemical composition were found across the center area of the mount. Figure 12 shows the EDS spectrum of one such area with an overlay of its original and enhanced micrograph. Overlaid onto that spectrum is a second spectrum, black, at the same magnification, but from an area beyond the center area.

Figure 12. EDS spectrum and micrograph of a polished slug mount.

The red spectrum has two copper (Cu) peaks; the left hand peak is a Cu L line also seen in the blue/purple spectrum, while two right hand peaks in red are the Cu K doublet lines. This shows that, for the bulk alloy, there was not a sufficient Cu concentration to produce a K line, nominally about than 0.1 weight-percent. Although methylene chloride, CH₂Cl₂, was used to sonically clean the mounts, no detectable levels of chlorine where found on the regular surface. The existence of unanticipated chemical species threatened the capability to accurately characterize functionalized materials. The cause of the physical and chemical differences was immaterial to the project and not investigated further.

Secondly, existing polished mounts will be plasma coated in-house with either gold or platinum as piggy back efforts. Those coatings will improve in the examination of functionalize materials, filled resins, and polymer thin films. In some instances, the use of a variable pressure FE-SEM will be required, but not as a standard requirement. An alternative to plasma coating might be the use of gold leaf to overlay the surface of the mounts, using a thinned conductive adhesive interface layer. While gold leaf is cost effective, the time required to achieve the skill level required to handle and apply the leaf is difficult to justify.
